RP 21

# GUIDE TO COMMON SHIPBOARD EXPENDABLE BATHYTHERMOGRAPH (SXBT) RECORDING MALFUNCTIONS

BARRY P. BLUMENTHAL  
STEPHEN M. KRONER

AUGUST 1978  
REVISED FEBRUARY 1981

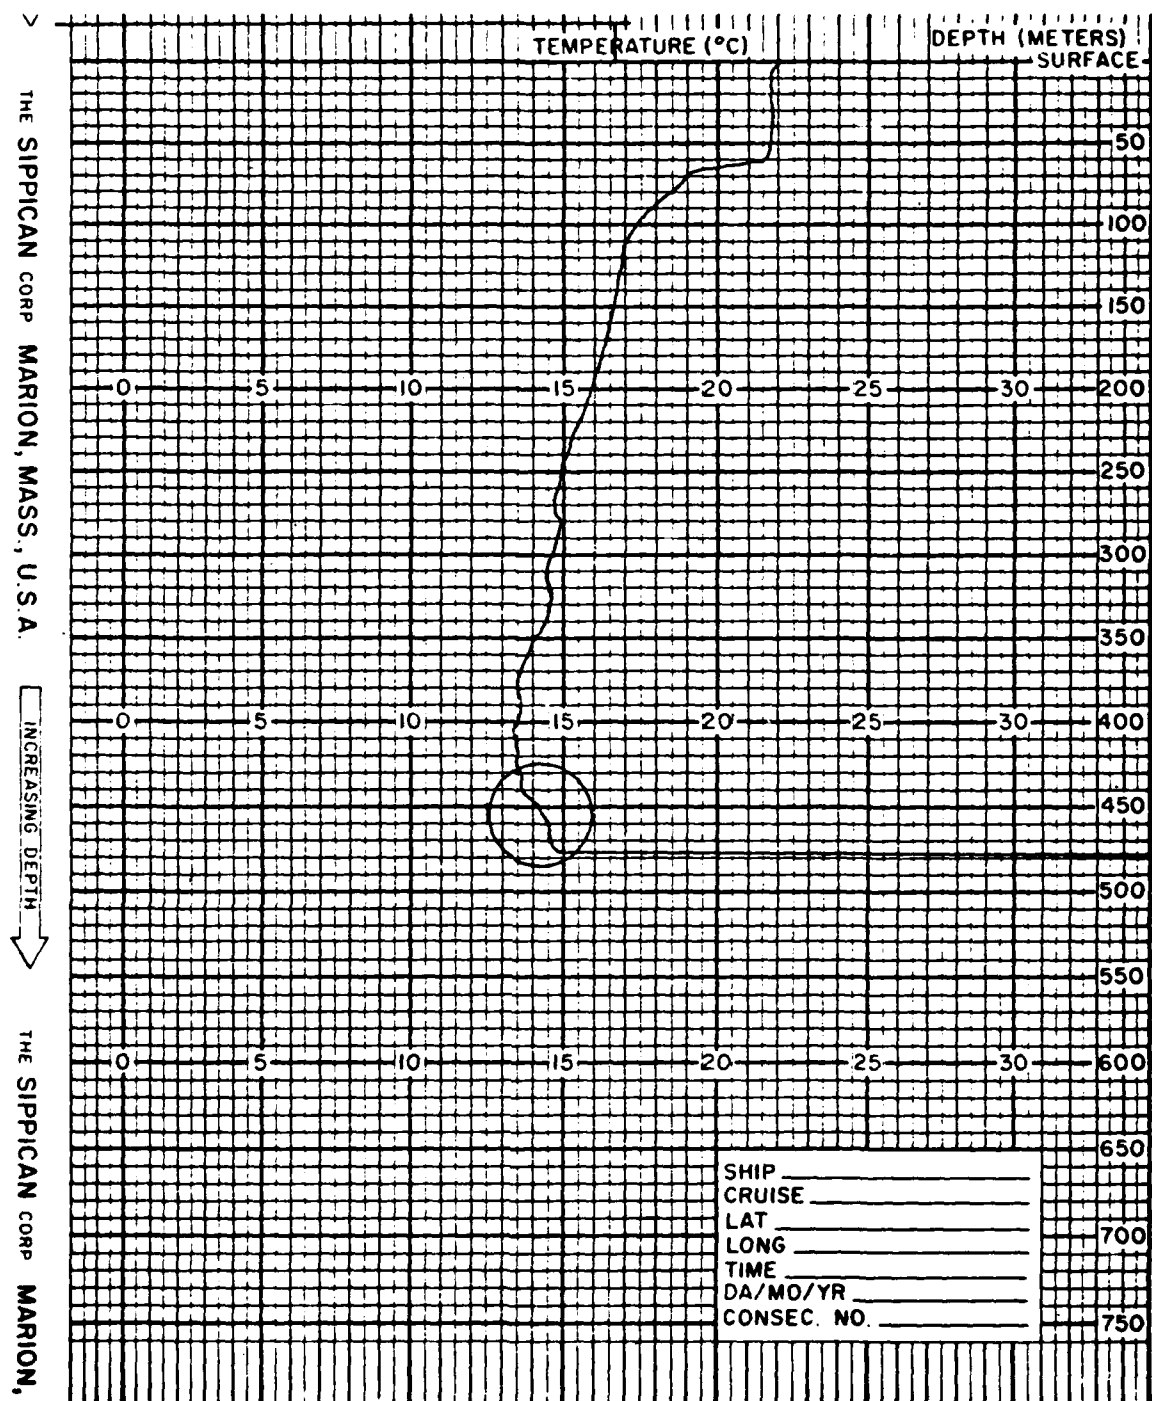
Category 6 - Wire stretch: Increased tension due to poor wire unreeling leads to wire stretch. This results in a characteristic bulge to the high-temperature side that can occur at any point in the trace (figures 15, 16, and 17). Data recorded beyond the stretch point are erroneous because of a permanent change in the conductive characteristics of the wire.

Figure 17 - Wire stretch at bottom of trace resulting in false temperature increase

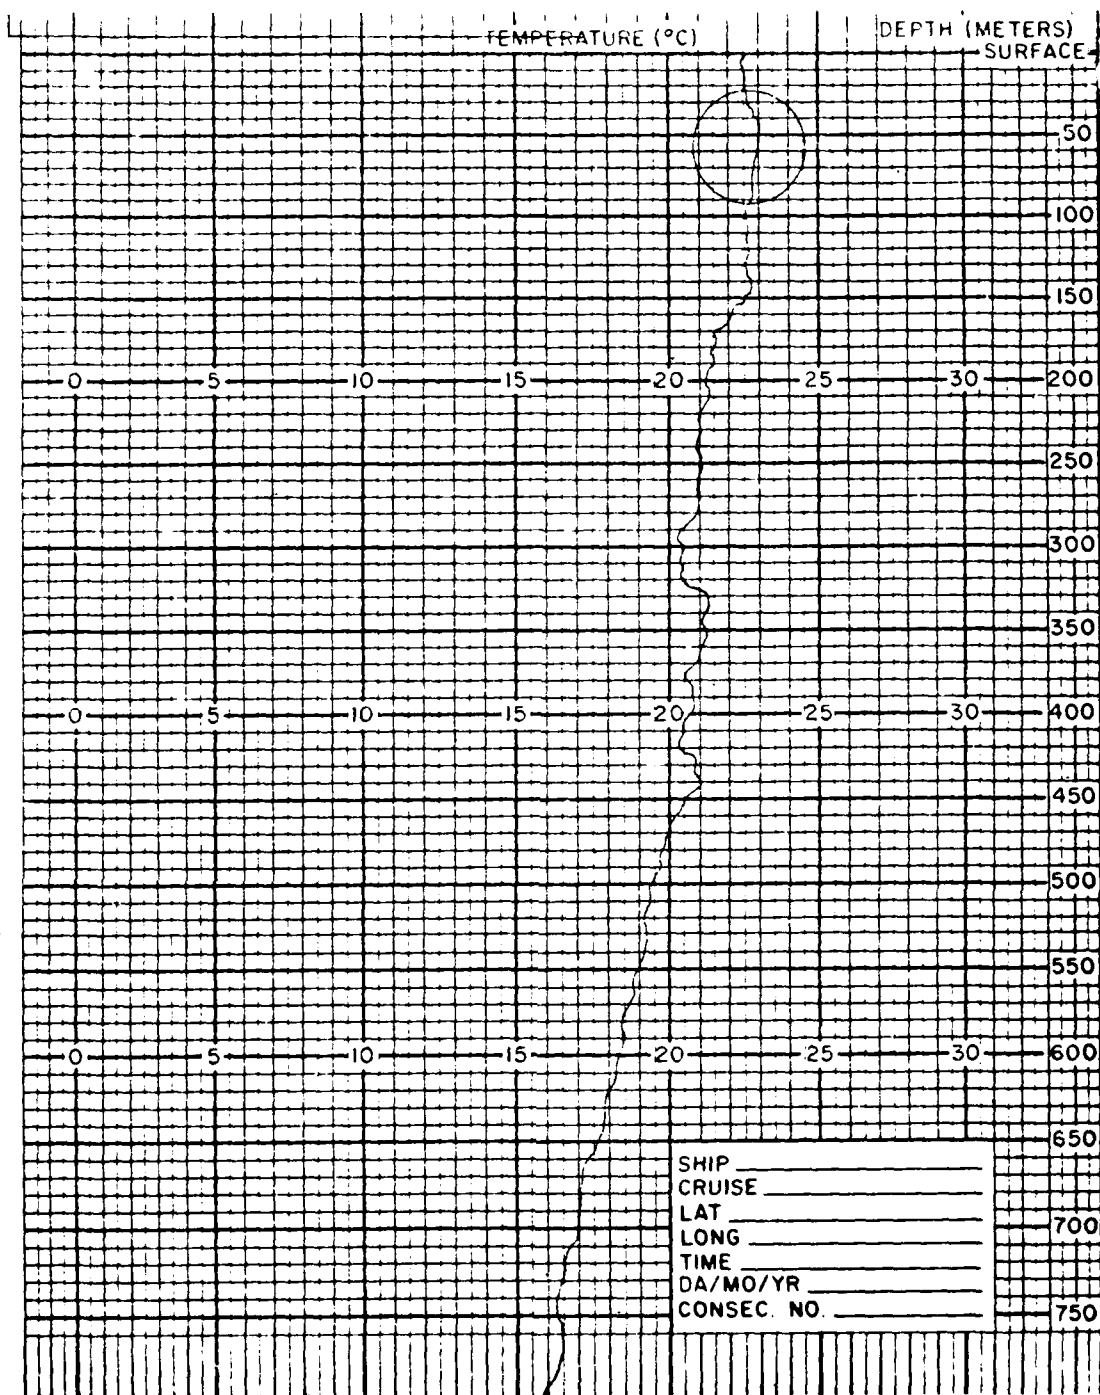
Category 7 - Improper ground or leakage at launcher: Figures 18 and 19 show the results of a faulty launcher ground and an electrical leakage at the launcher, respectively. Both traces are erroneous. Possible causes for these problems are 1) improper grounding of the deck-mounted launcher, 2) leakage caused by corrosion or moisture at the canister contacts in the launcher breech, or 3) launcher-to-recorder cable leakage. Launcher and ground connections should be checked to assure proper contacts and electrical continuity of the system. The operator is referred to the Sippican Corporation Instruction Manual for the Expendable Bathythermograph System (1975) for adjustment and troubleshooting procedures.

Figure 18 - Improper launcher ground - erratic excursion to high temperature end

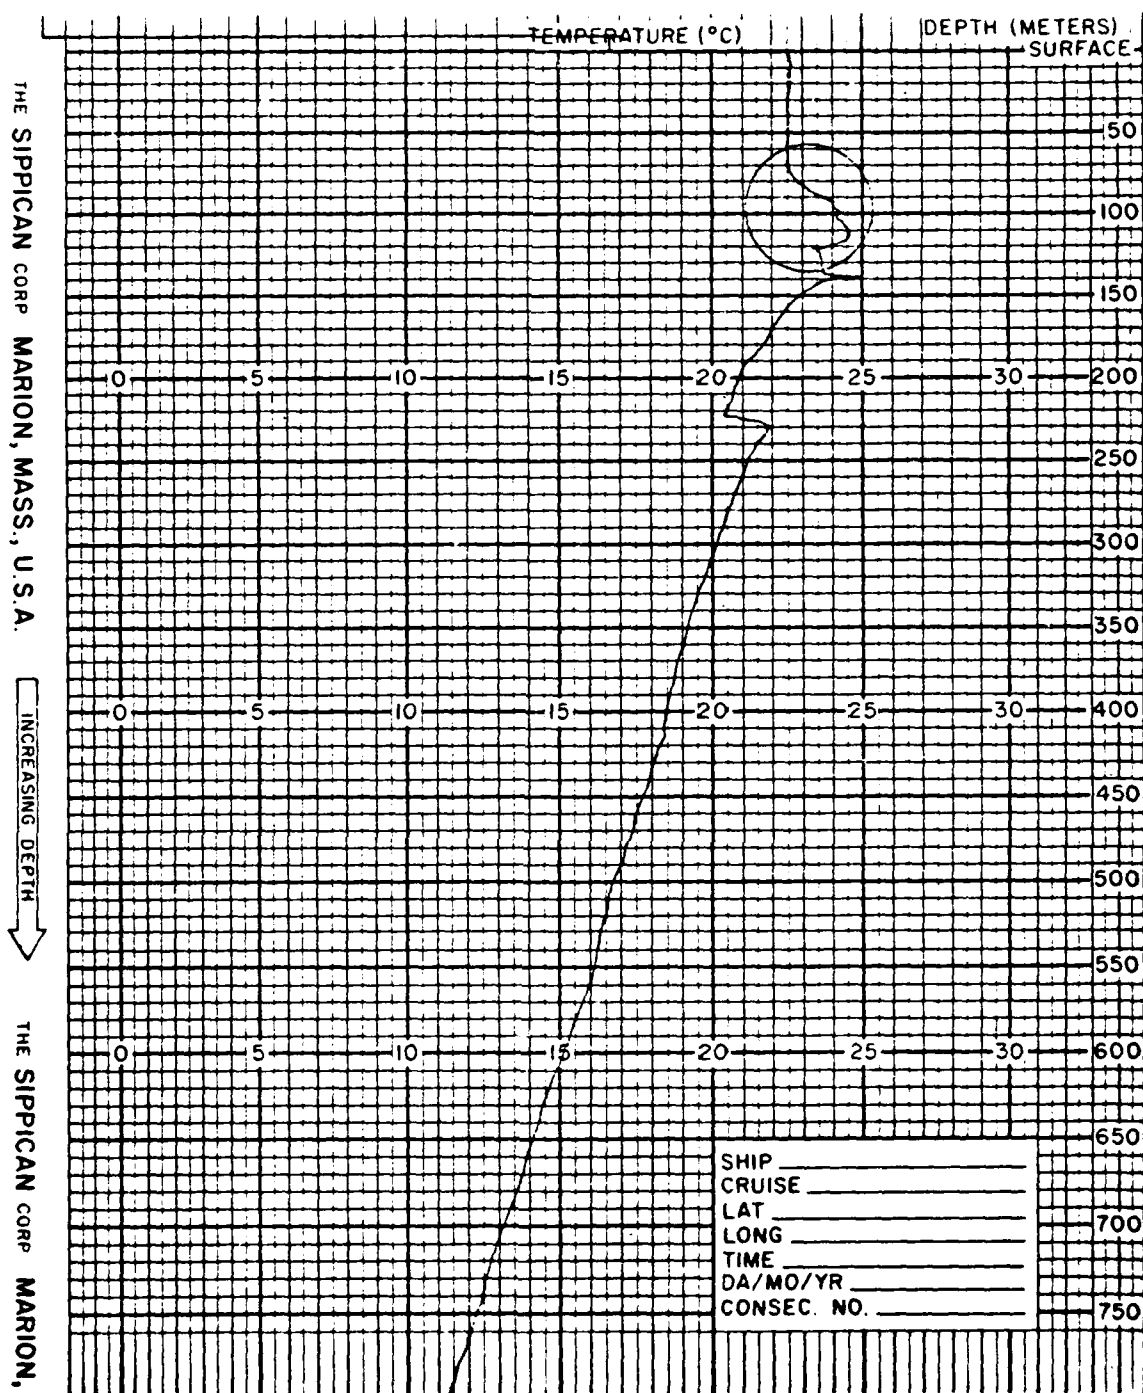
Figure 19 - Launcher leakage (at 65 m)

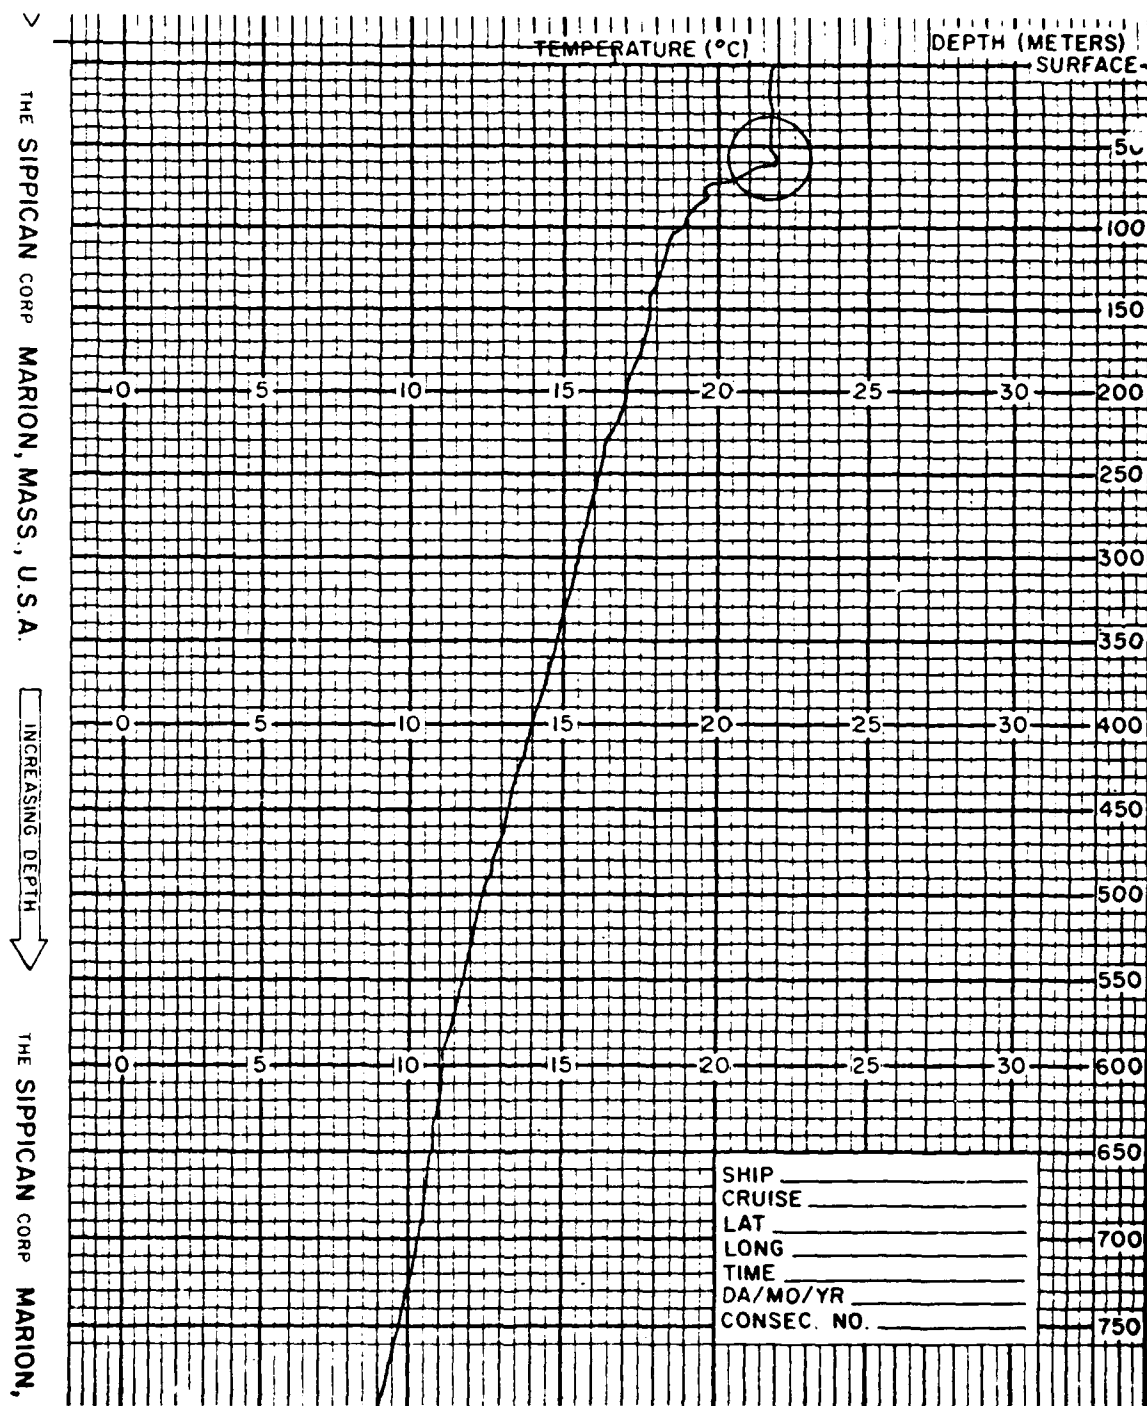
Category 8 - Doubtful features: Without knowledge of expected oceanographic conditions, an observer can have difficulty discerning good data from bad data. Figures 20 and 21 display features which may or may not be real. Comparison should be made between succeeding traces in the same area to determine if the feature is real. Doubtful features can appear at any point in the trace. Care must be taken, however, in labeling features as doubtful. Variations in thermal structure do exist, particularly in regions of oceanic fronts and eddies, but they can also occur in relatively stable regions.

Figure 20 - Doubtful feature within the mixed layer

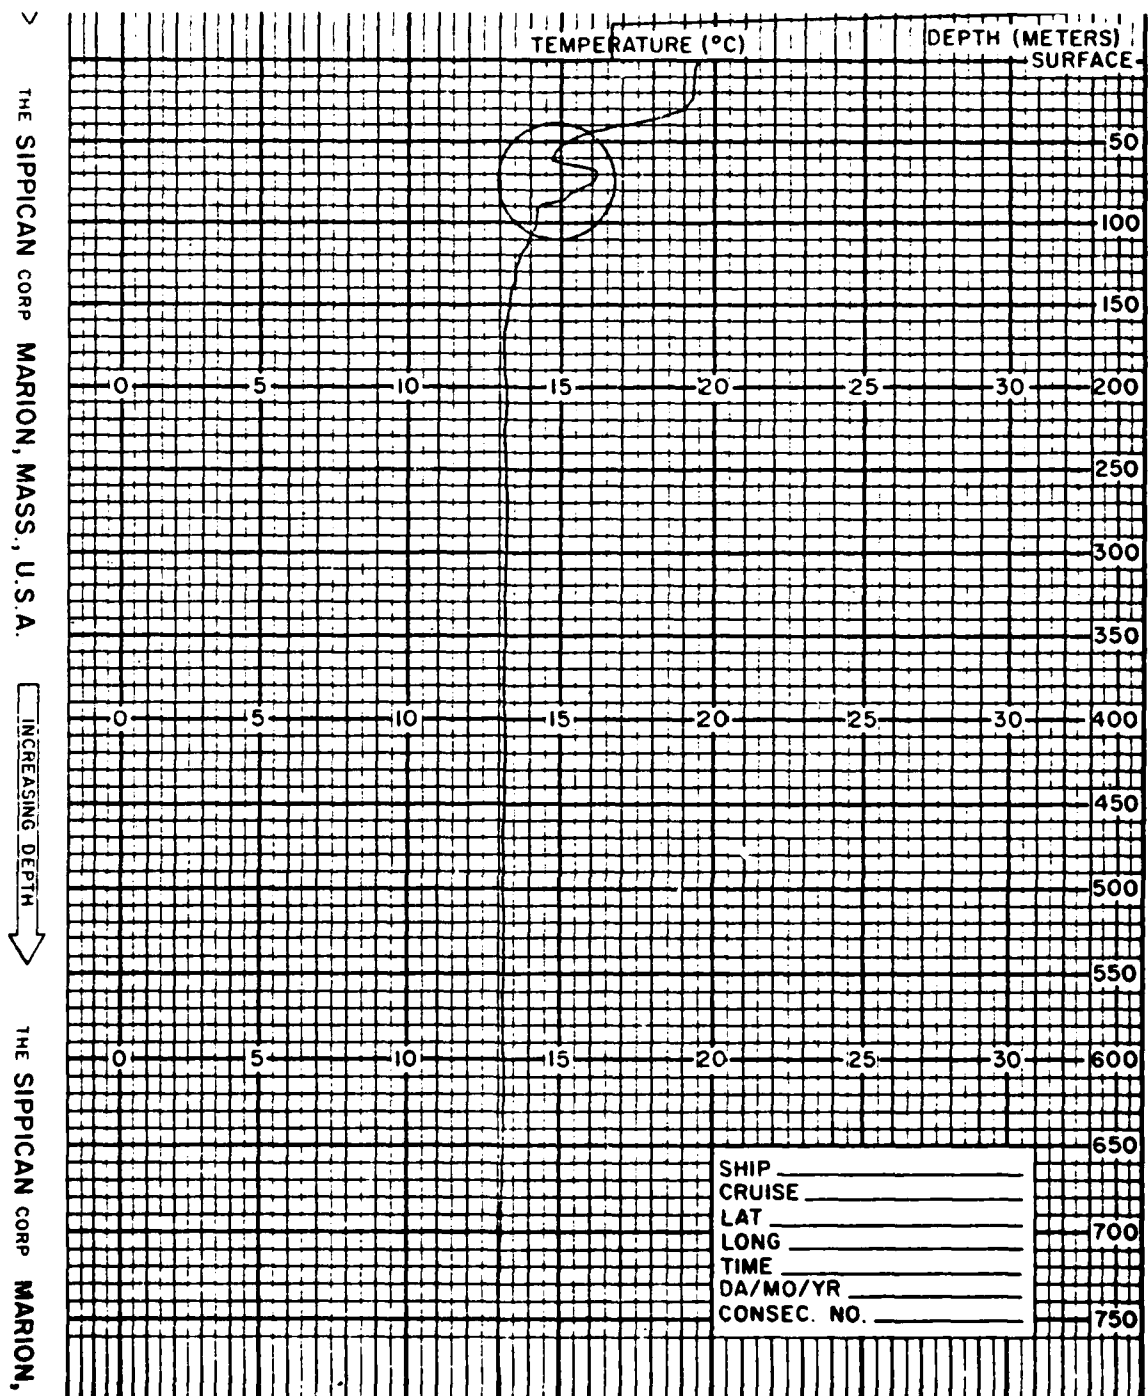
Figure 21 - Doubtful feature within the permanent thermocline

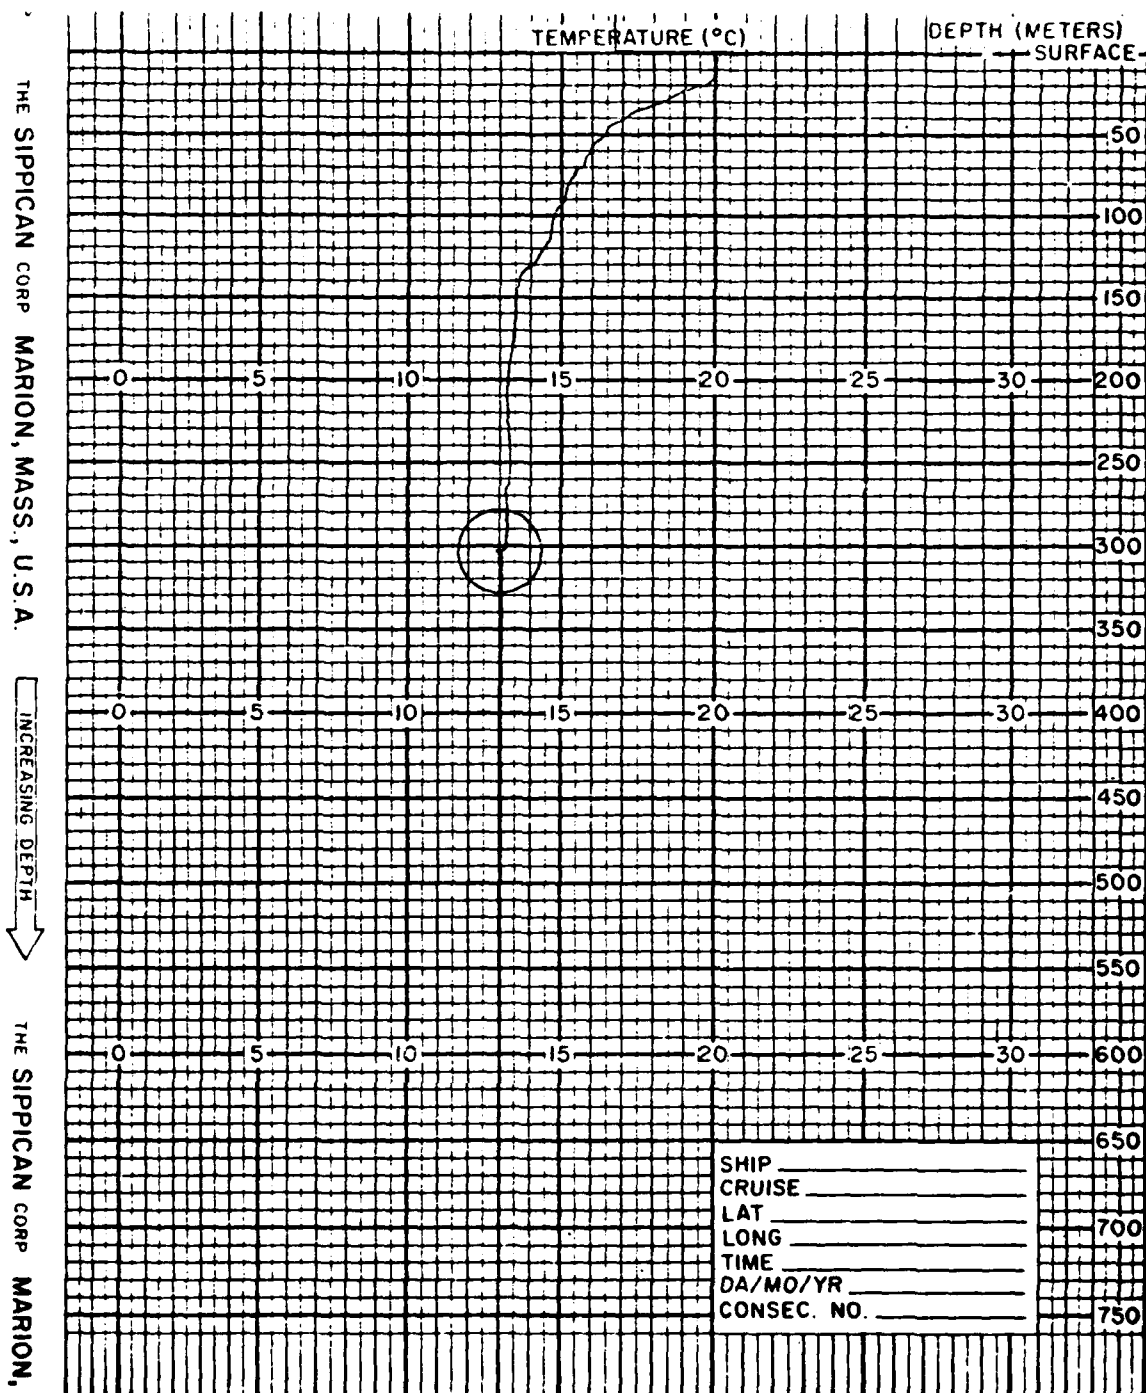
Probe hits bottom: When bottom depth is less than the rated depth of a probe, bottoming occurs (figures 22 and 23). An indication that a probe has hit bottom is given by a small horizontal spike in the trace followed by an isothermal reading. However, little or no spiking may appear if the bottom is soft. In shallow areas, it is important to know the bottom depth so that false data do not result from encoding data below the actual bottom.

Figure 22 - Shallow drop - bottom spike (at 302 m) followed by isothermal reading as probe lies on bottom

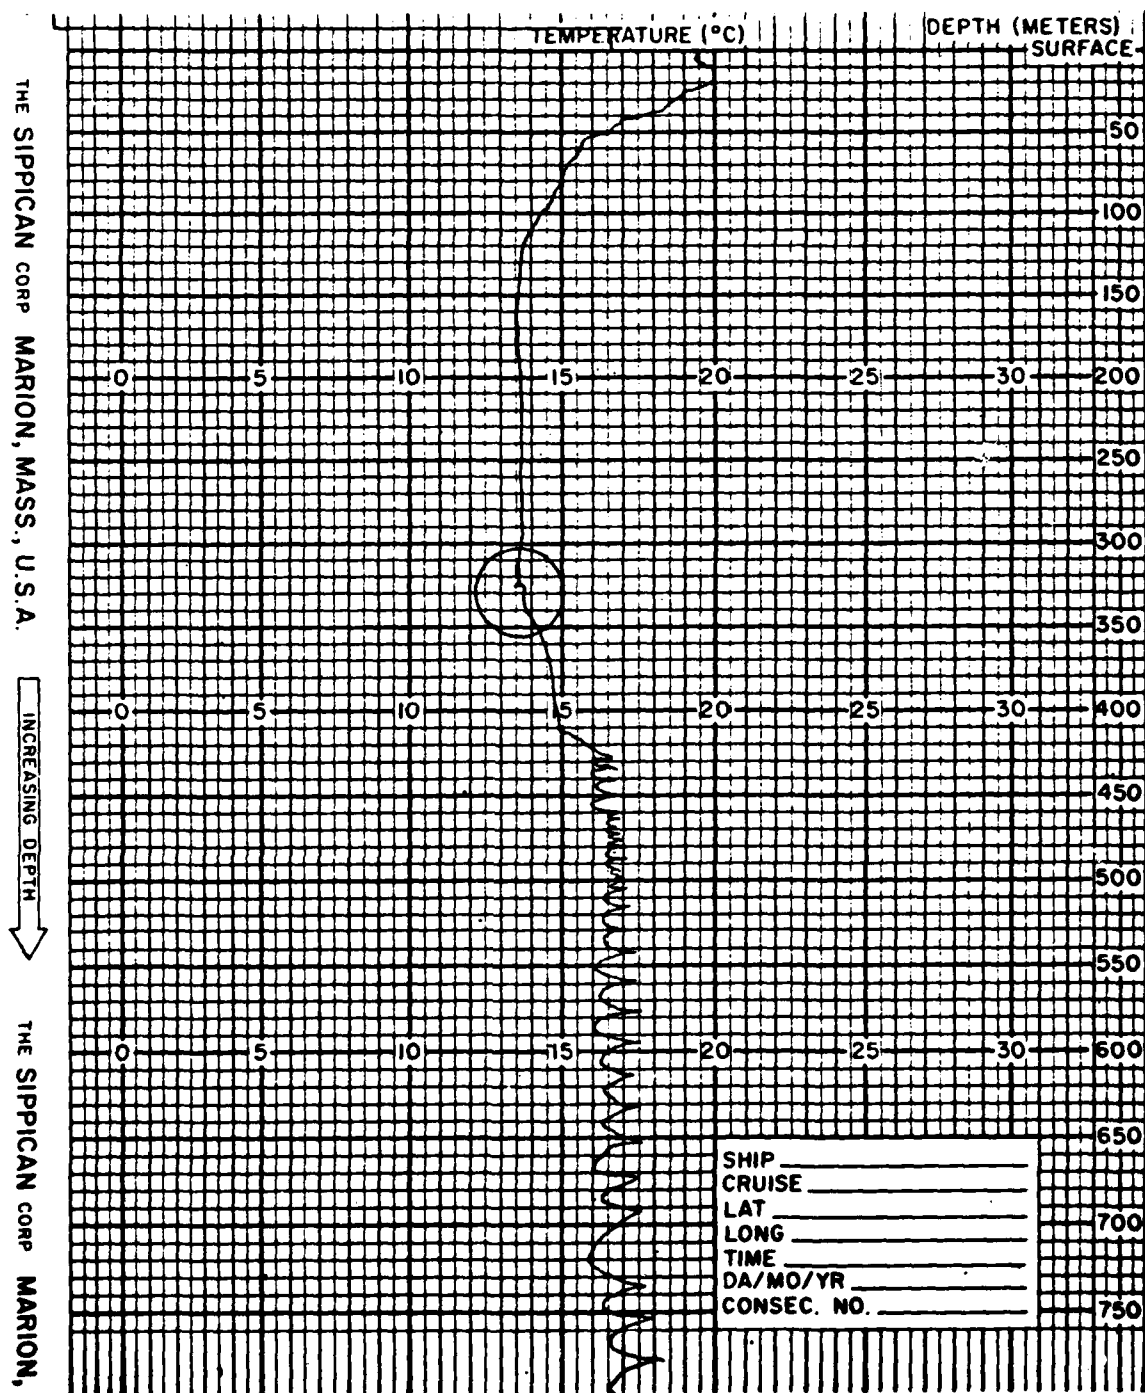
Figure 23 - Shallow drop - bottom spike (at 326 m) followed by wire leakage
